Mount Morris Lake

Comprehensive Management Plan

April 2013

Created by: Brenton Butterfield, Dan Cibulka, Eddie Heath, and Tim Hoyman
Onterra, LLC
De Pere, WI

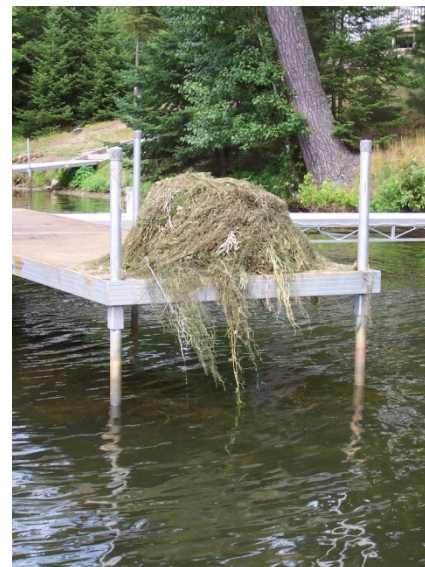
Manual removal methods include hand-pulling, raking, and hand-cutting. Hand-pulling involves the manual removal of whole plants, including roots, from the area of concern and disposing them out of the waterbody. Raking entails the removal of partial and whole plants from the lake by dragging a rake with a rope tied to it through plant beds. Specially designed rakes are available from commercial sources or an asphalt rake can be used. Hand-cutting differs from the other two manual methods because the entire plant is not removed, rather the plants are cut similar to mowing a lawn; however Wisconsin law states that all plant fragments must be removed. One manual cutting technique involves throwing a specialized “V” shaped cutter into the plant bed and retrieving it with a rope. The raking method entails the use of a two-sided straight blade on a telescoping pole that is swiped back and forth at the base of the undesired plants.

In addition to the hand-cutting methods described above, powered cutters are now available for mounting on boats. Some are mounted in a similar fashion to electric trolling motors and offer a 4-foot cutting width, while larger models require complicated mounting procedures, but offer an 8-foot cutting width. Please note that the use of powered cutters may require a mechanical harvesting permit to be issued by the WDNR.

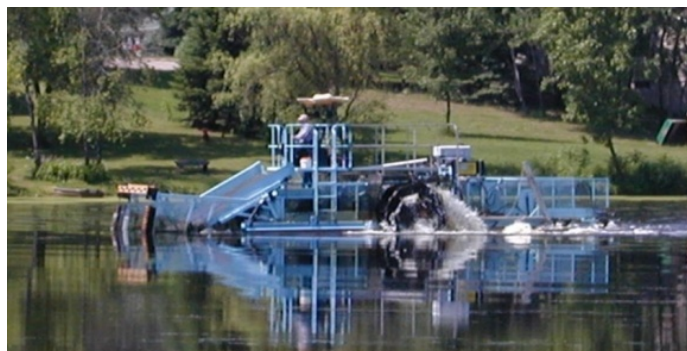
Aquatic plant harvesting is frequently used in Wisconsin and involves the cutting and removal of plants much like mowing and bagging a lawn. Harvesters are produced in many sizes that can cut to depths ranging from 3 to 6 feet with cutting widths of 4 to 10 feet. Plant harvesting speeds vary with the size of the harvester, density and types of plants, and the distance to the off-loading area. Equipment requirements do not end with the harvester. In addition to the harvester, a shore-conveyor would be required to transfer plant material from the harvester to a dump truck for transport to a landfill or compost site. Furthermore, if off-loading sites are limited and/or the lake is large, a transport barge may be needed to move the harvested plants from the harvester to the shore in order to cut back on the time that the harvester spends traveling to the shore conveyor. Some lake organizations contract to have nuisance plants harvested, while others choose to purchase their own equipment. If the latter route is chosen, it is especially important for the lake group to be very organized and realize that there is a great deal of work and expense involved with the purchase, operation, maintenance, and storage of an aquatic plant harvester. In either case, planning is very important to minimize environmental effects and maximize benefits.
