Mount Morris Lake
 Waushara County, Wisconsin

**2007 Curly-leaf Pondweed
 Chemical Treatment**

INTRODUCTION

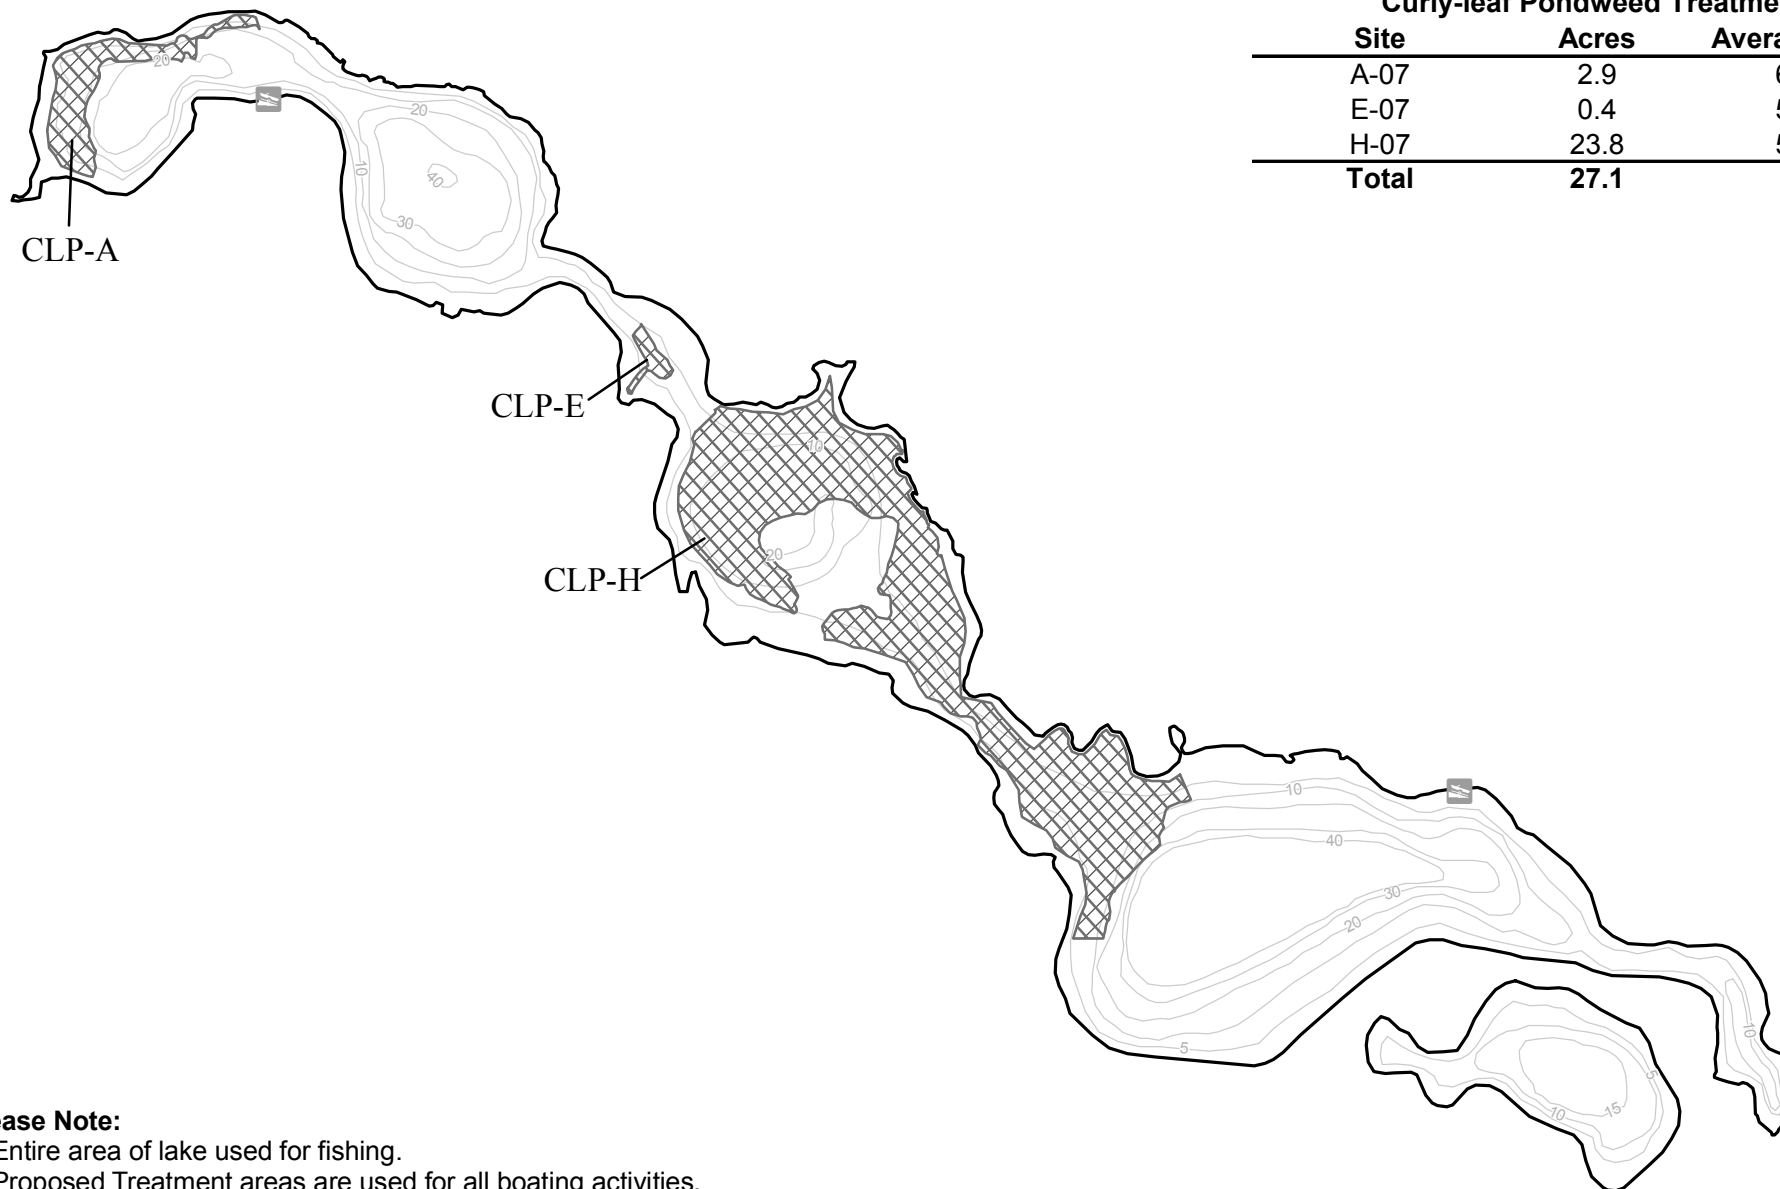
Map 1

Curly-leaf Pondweed Treatment		
Site	Acres	Average Depth
A-07	2.9	6 feet
E-07	0.4	5 feet
H-07	23.8	5 feet
Total	27.1

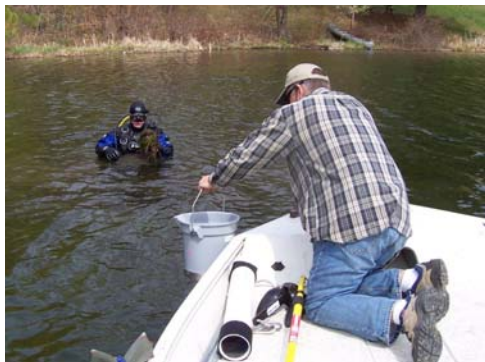
Photo 1. Tim Hoyman (left), adorning cold-water scuba gear, transferring removed EWM to Rob Adams (right) near the boat landing in Lake D.

No chemical treatment was recommended for the aforementioned EWM occurrences, but on April 28, Onterra ecologists and Rob Adams of the MMLMD conducted hand removal of EWM near the boat landing in Lake D (Map 4, EWM-C). High traffic areas such as this one can contribute to the spreading of this plant throughout the lake. As boats move through the EWM colony, they can cut the plant into fragments that have the potential of taking root in other locations of the lake. Using scuba, Tim Hoyman (Onterra) removed the EWM plants including the entire root, and brought them to the surface where they were loaded into the boat. It was presumed that this control method was largely effective, and later field visits verified its success.

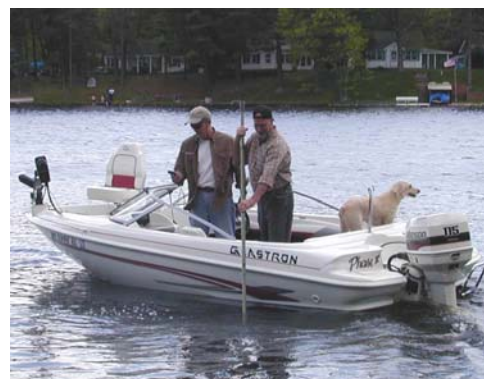
Photo 2. Rob Adams (left) navigating with the GPS while Gary Frank (right) conducts a rake-tow as part of the post treatment monitoring on Mount Morris Lake.

Onterra provided a handheld GPS unit loaded with the 59 point-intercept locations discussed above to the MMLMD volunteers for use in their surveys. They were trained how to use the provided GPS and navigate to the sample locations. Two rake-tow samples were taken at each location and data was collected on CLP occurrence and overall health of the plants (e.g. healthy, dead, or dying). Additionally, two Ponar dredge samples were taken at each

location to determine if the chemical treatments were affecting the turion counts from the sediments. Please note that during this survey, the rope to the Ponar dredge broke and left it at the bottom of the lake with 21 sample locations left to survey. On May 20, 2006, these locations were sampled for CLP occurrence and condition and a later field survey (with a new Ponar dredge) sampled these locations for turions.

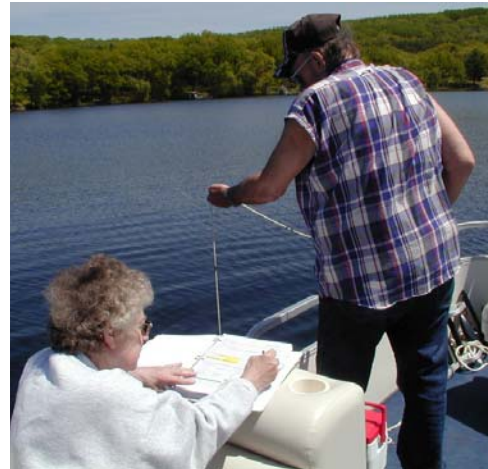
Photo 3. Betty and Bob Mueller collecting water quality samples on Mount Morris Lake.

Stakeholders were solicited to help monitor the water quality in Mount Morris Lakes during the growing seasons of this 4 year project. In the first year, volunteers were trained to collect water quality samples from the deep holes of Lakes C and D. Near-surface and near-bottom samples were collected twice a month May – August and analyzed for total and soluble reactive (ortho) phosphorus by the Wisconsin State Laboratory of Hygiene.

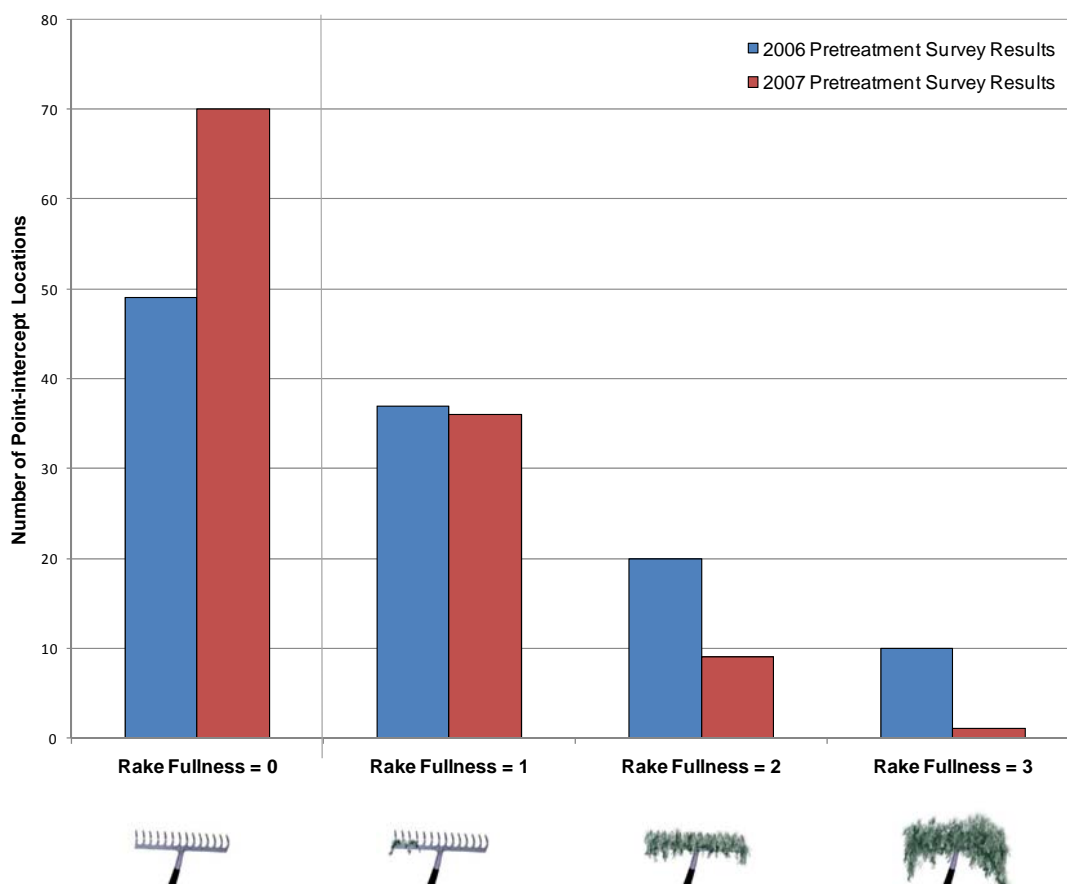
Figure 1. EWM rake fullness distribution from 2006-2007 pretreatment surveys on Mount Morris Lake. This data is based on the 59 point-intercept locations shown in Appendix A – Map.

During the 2006 pretreatment survey, 58.5% of the point-intercept locations contained CLP and 40.7% contained CLP during the 2007 pretreatment survey (Table 1). A rake fullness rating of 1-3 was used to determine abundance of the CLP at each location. Figure 1 displays the number of point-intercept locations exhibiting each of the rake fullness ratings within Mount Morris Lake. These data shows that along with the observed reduction in CLP occurrence (Table 1), a reduction in CLP density was also documented (Figure 1). During the 2006 pretreatment survey, 44.8% of the point-intercept locations that contained CLP exhibited a rake fullness rating greater than 1. The 2007 pretreatment survey data yielded only 21.7 % of the CLP occurrences displaying a rake fullness of greater than 1 (Figure 1).

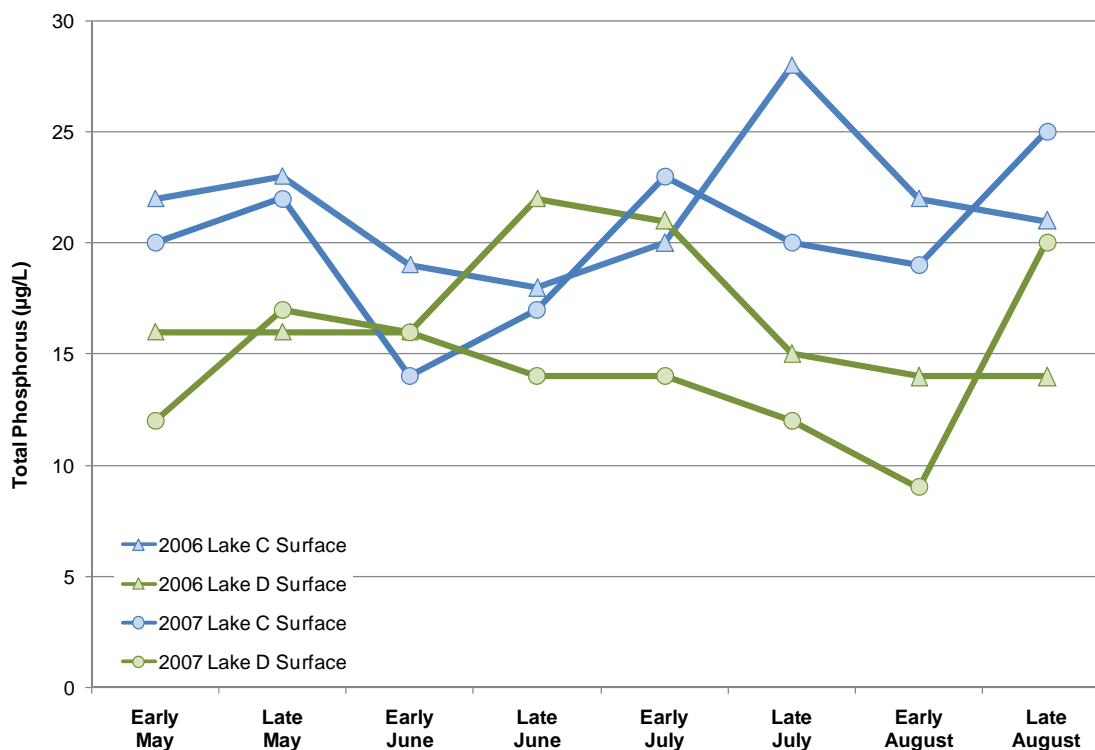
Figure 2. Surface total phosphorus values from Mount Morris Lake.

In 2004, surface total phosphorus values in Lake D spiked at over 40 µg/L during July. These concentrations coincide with the large-scale die off of CLP within the Lake. During July of 2006 and 2007, almost no such spike can be observed (Figure 2); especially at the magnitude that was observed in 2004 before treatments occurred (40 µg/L).
