**Mount Morris Lake**  
Waushara County, Wisconsin  
**Final 2021-2023 Water Level Drawdown Report**  
April 2024

Created by: Eddie Heath, Todd Hanke, & Tim Hoyman  
Onterra, LLC  
De Pere, WI

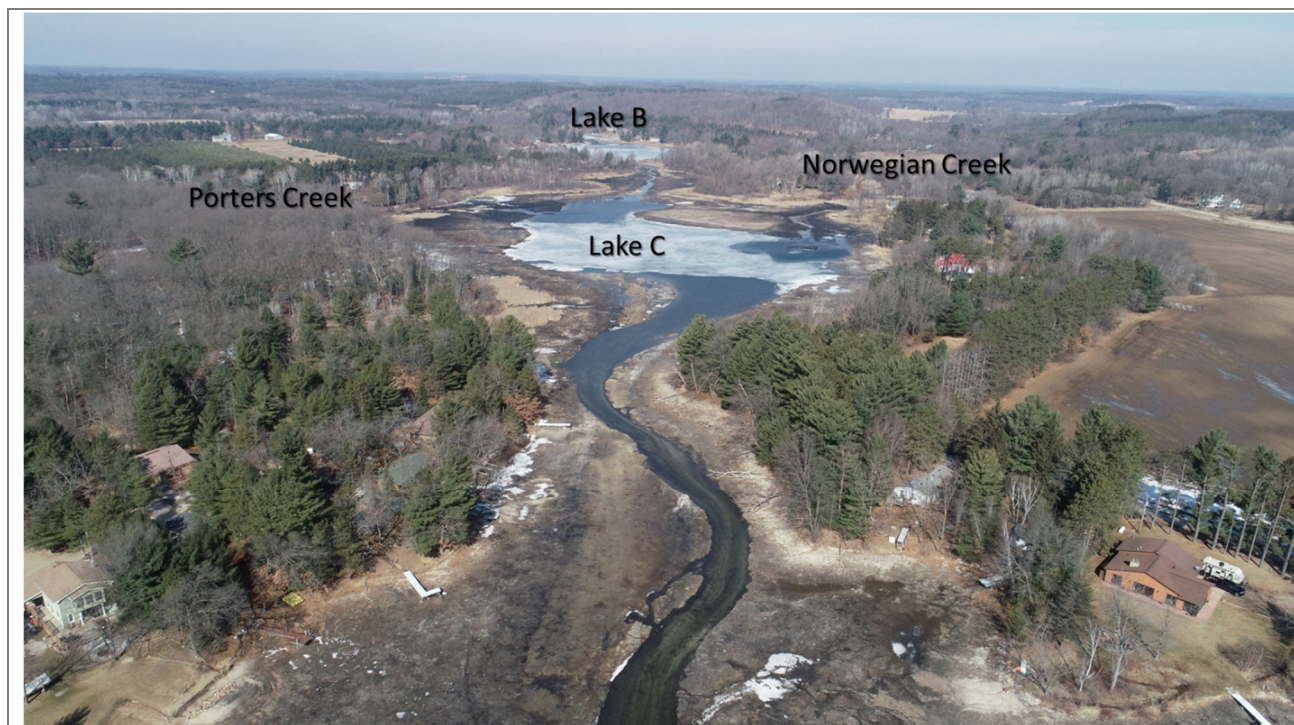
**Photograph 1.2-1. Aerial photo of Mount Morris Lake during winter drawdown.** Photo credit: Onterra, LLC March 16, 2022.

In Mid-March, Onterra volunteered to collect photos and videos of the dewatered condition, some with the assistance of an aerial drone. The site visit confirms areas of exposed lakebed and channel cutting between basins (Photo 1.2-1). More videos and pictures were compiled into an approximately 4-minute YouTube video: <https://youtu.be/kaheIT87g80>

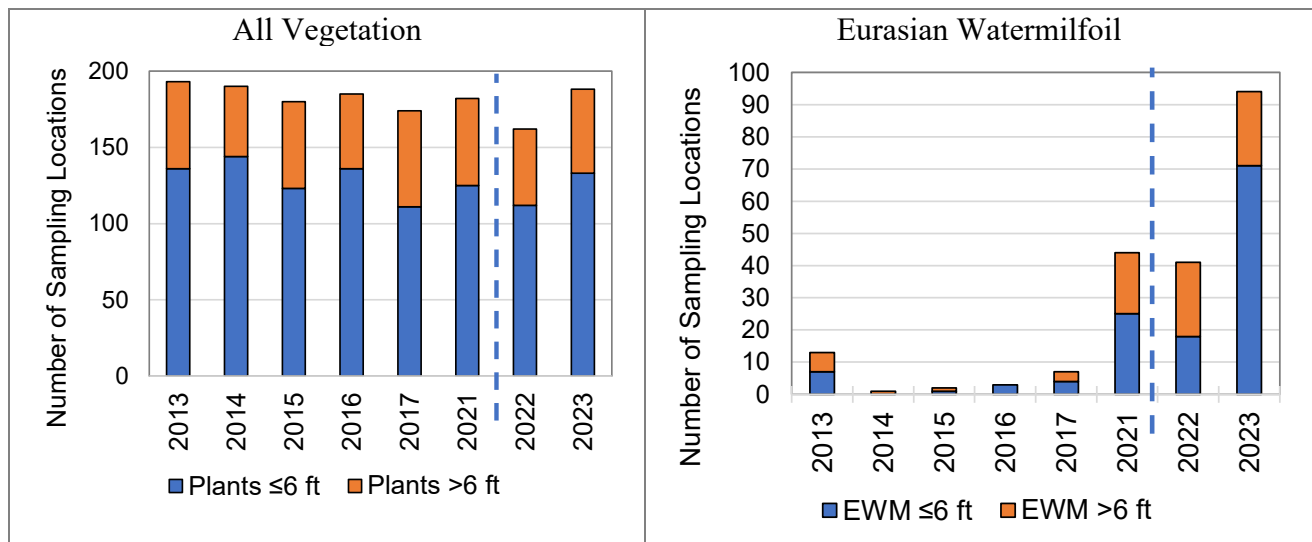
**Figure 2.1-2. Vegetation growing in waters 6 feet and less vs greater than 6 feet.**

Figure 2.1-2 investigates the depths at which vegetation, and specifically EWM, are growing at in Mount Morris Lake based upon the point-intercept survey. Plants growing in 6 feet of less would be anticipated to be impacted by the drawdown, whereas plants growing out deeper would not. During 2021 before the winter drawdown, more than half of all the EWM was growing in waters under 6 feet. During the year of refill (2022), slightly more than half the EWM was growing in waters greater than 6 feet. EWM recolonized back in waters less than 6 feet deep during the *year after refill* (2023).

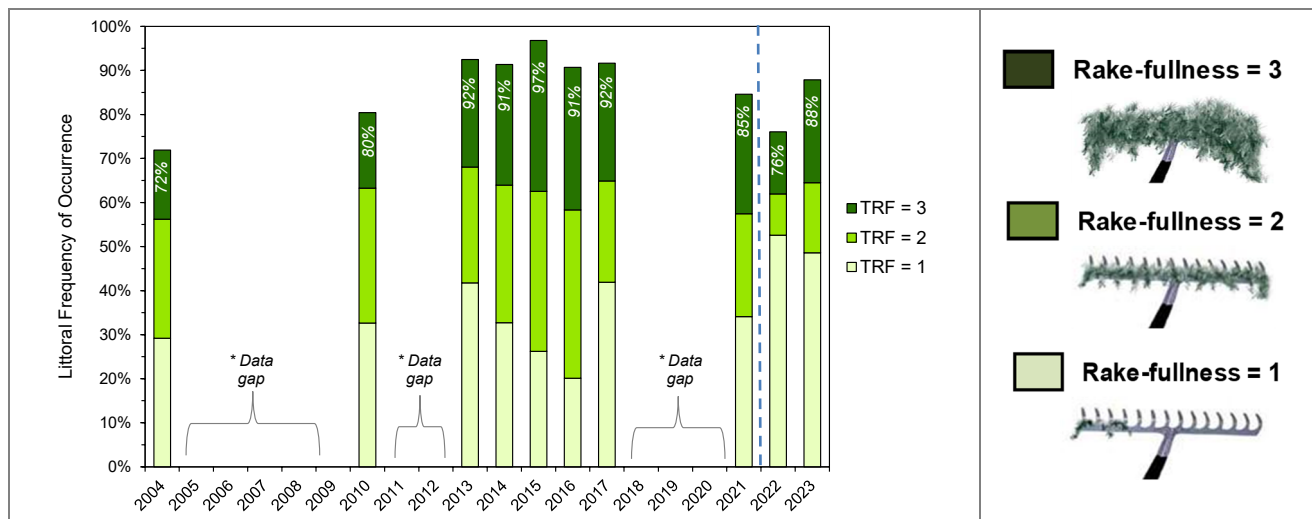
**Figure 2.1-3. Mount Morris Lake aquatic vegetation total rake fullness ratings.** The dashed blue line signifies the winter 2021-22 drawdown event.

Whole-lake point-intercept surveys are used to quantify the abundance of individual plant species within the lake. Of the 214 point-intercept sampling locations that fell at or shallower than the maximum depth of plant growth (i.e. littoral zone) in Mount Morris Lake in 2023, approximately 87% contained aquatic vegetation. The total rake fullness (TRF) data indicates that where aquatic plants are present in Mount Morris Lake, they are at a moderate to high abundance. Total rake fullness levels have historically been very similar with a high abundance of plant biomass (Figure 2.1-3).

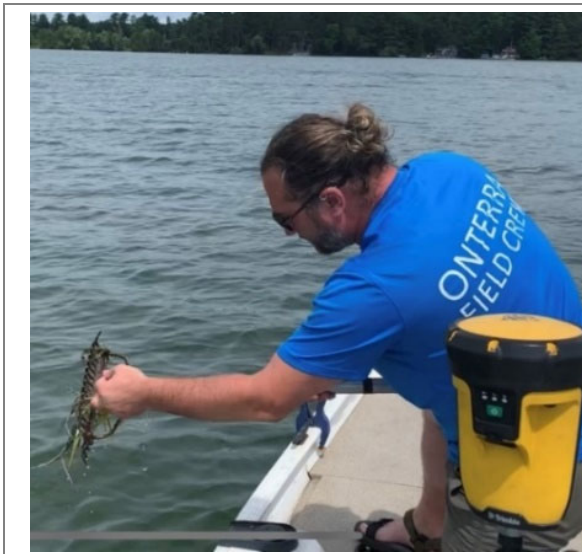
**Photograph 2.3-1. Point-intercept survey on a WI lake.** Photo credit Onterra.

The point-intercept survey provides a standardized way to gain quantitative information about a lake's aquatic plant population through visiting predetermined locations (Map 1) and using a rake sampler to identify all the plants at each location (Photograph 2.3-1). The survey methodology allows comparisons to be made over time, as well as between lakes. The point-intercept survey is most often applied at the whole-lake scale as has been presented above.

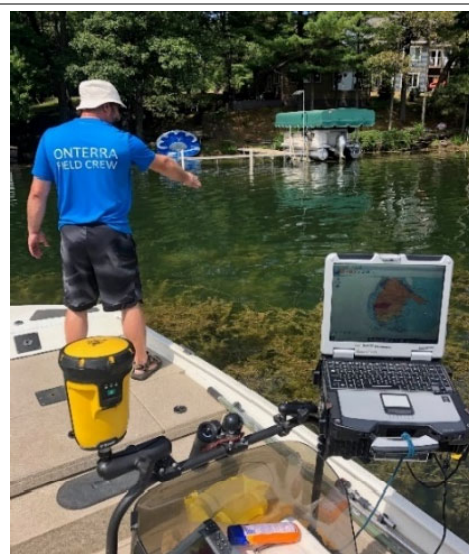
**Photo 2.3-2. EWM mapping survey on a Wisconsin lake.** Photo credit Onterra.

While the point-intercept survey is a valuable tool to understand the overall plant population of a lake, it does not offer a full account (census) of where a particular species exists in the lake. EWM grows high in the water column, which can cause recreation and navigation impediments. This factor allows it to typically be mapped through surface observation. During an EWM mapping survey, the entire littoral area of the lake is surveyed through visual observations from the boat (Photograph 2.3-2). Field crews may supplement the visual survey by deploying a submersible camera along with periodically doing rake tows. The EWM population is mapped using sub-meter GPS technology by using either 1) point-based or 2) area-based methodologies. Large colonies >40 feet in diameter are mapped using polygons (areas) and are qualitatively attributed a density rating based upon a five-tiered scale from *highly scattered* to *surface matting*. Point-based techniques were applied to AIS locations that were considered as *small plant colonies* (<40 feet in diameter), *clumps of plants*, or *single or few plants*.

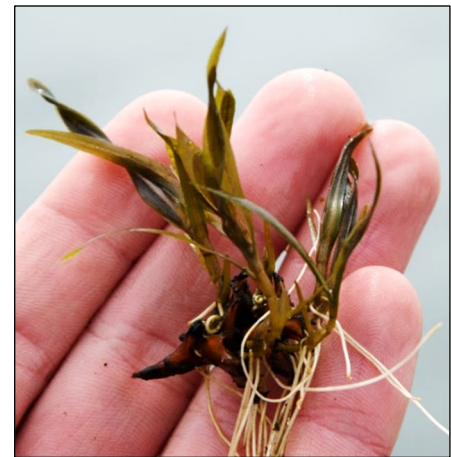
**Photograph 2.3-4. Single CLP turion sprouting several new plants.** Photo credit Onterra.

Like some of Wisconsin's native pondweeds, CLP's primary method of propagation is through the production of numerous asexual reproductive structures called turions. Once mature, these turions break free from the parent plant and may float for some time before settling and overwintering on the lake bottom. Once favorable growing conditions return (i.e., spring), new plants emerge and grow from these turions (Photograph 2.3-4). Many of the turions produced by CLP begin to sprout in the fall and overwinter as small plants under the ice. Immediately following ice-out, these plants grow rapidly giving them a competitive advantage over native vegetation. Curly-leaf pondweed typically reaches its peak biomass by mid-June, and following the production of turions, most of the CLP will naturally senesce (die back) by mid-July.

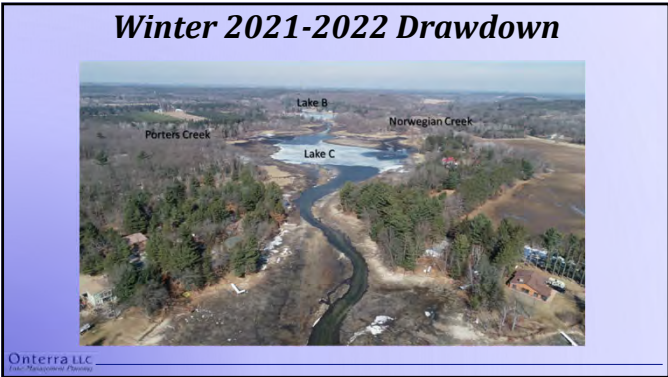
2023 CLP Survey

- *Year of refill* results indicate EWM control goals were not met
- CLP population may have dipped in 2022, but expansion in 2023
- Submergent plant community is healthy, potentially causing user impacts
- Floating-leaf community impacted greater than predictions
- Not much depth gained aside from channel cutting
- Recommendation: district to update their APM Plan accordingly
